## DUCK POND DAM

NDI ID NO. PA-00379  
DER ID NO. 35-98

### PHASE I INSPECTION REPORT NATIONAL DAM INSPECTION PROGRAM

June 1981

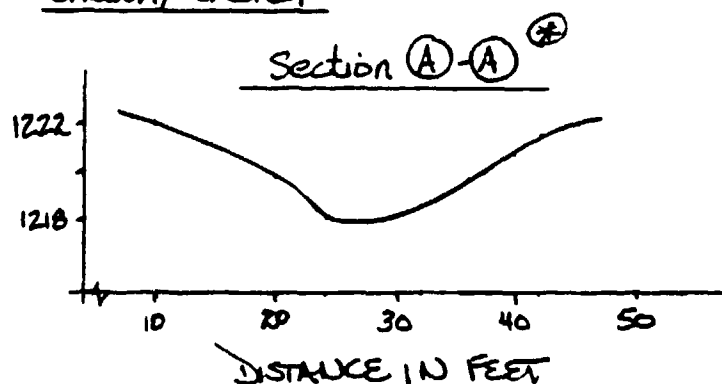
SPILLWAY SKETCH:

TYPE- TRAPEZODIAL SHAPED BROAD CRESTED WEIR  
LENGTH- BOTTOM WIDTH- 8 FEET  
TOP WIDTH - 22 FEET  
CREST ELEVATION- 1218.0 MSL  
LOW POINT TOP OF DAM - 1222.0 MSL  
SPILLWAY FREEBOARD - 4.0 FEET  
C VALUES SPILLWAY - 2.85  
EMBANKMENT - 2.85

DUE TO THE UNUSUAL  
CONFIGURATION OF  
THE SPILLWAY, OUTLET  
PIPE AND LOW AREA  
ADJACENT TO THE EM-  
BANKMENT, THE FOLLOWING  
VALUES ARE CALCULATED  
TO DETERMINE THE  
PEAK DISCHARGE CAPACITY  
OF THE SPILLWAY.
